Small Site Architecture of
Chaco Canyon
New Mexico

Peter J. McKenna
Marcia L. Truell

Publications in Archeology 18D
Chaco Canyon Studies

National Park Service
U.S. Department of the Interior

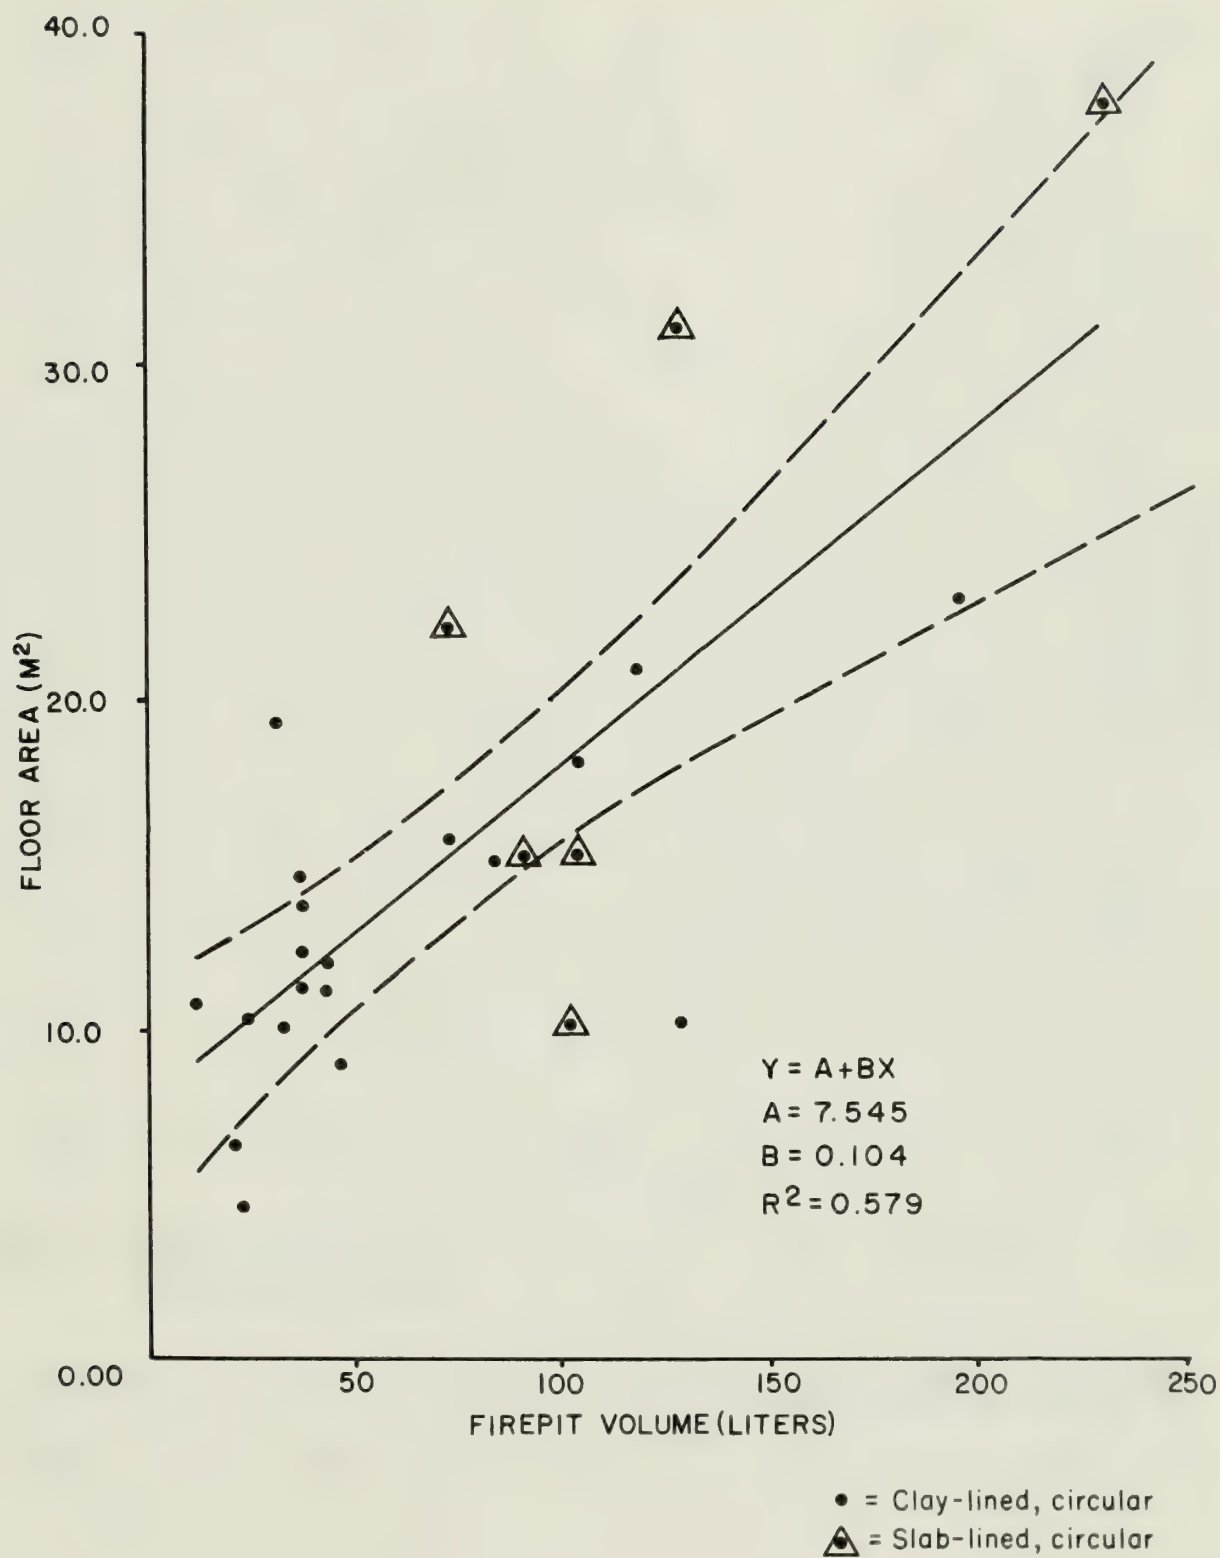
Figure 1.3. Pithouse floor area (Y) and firepit volumes (X), A.D. 500-700.

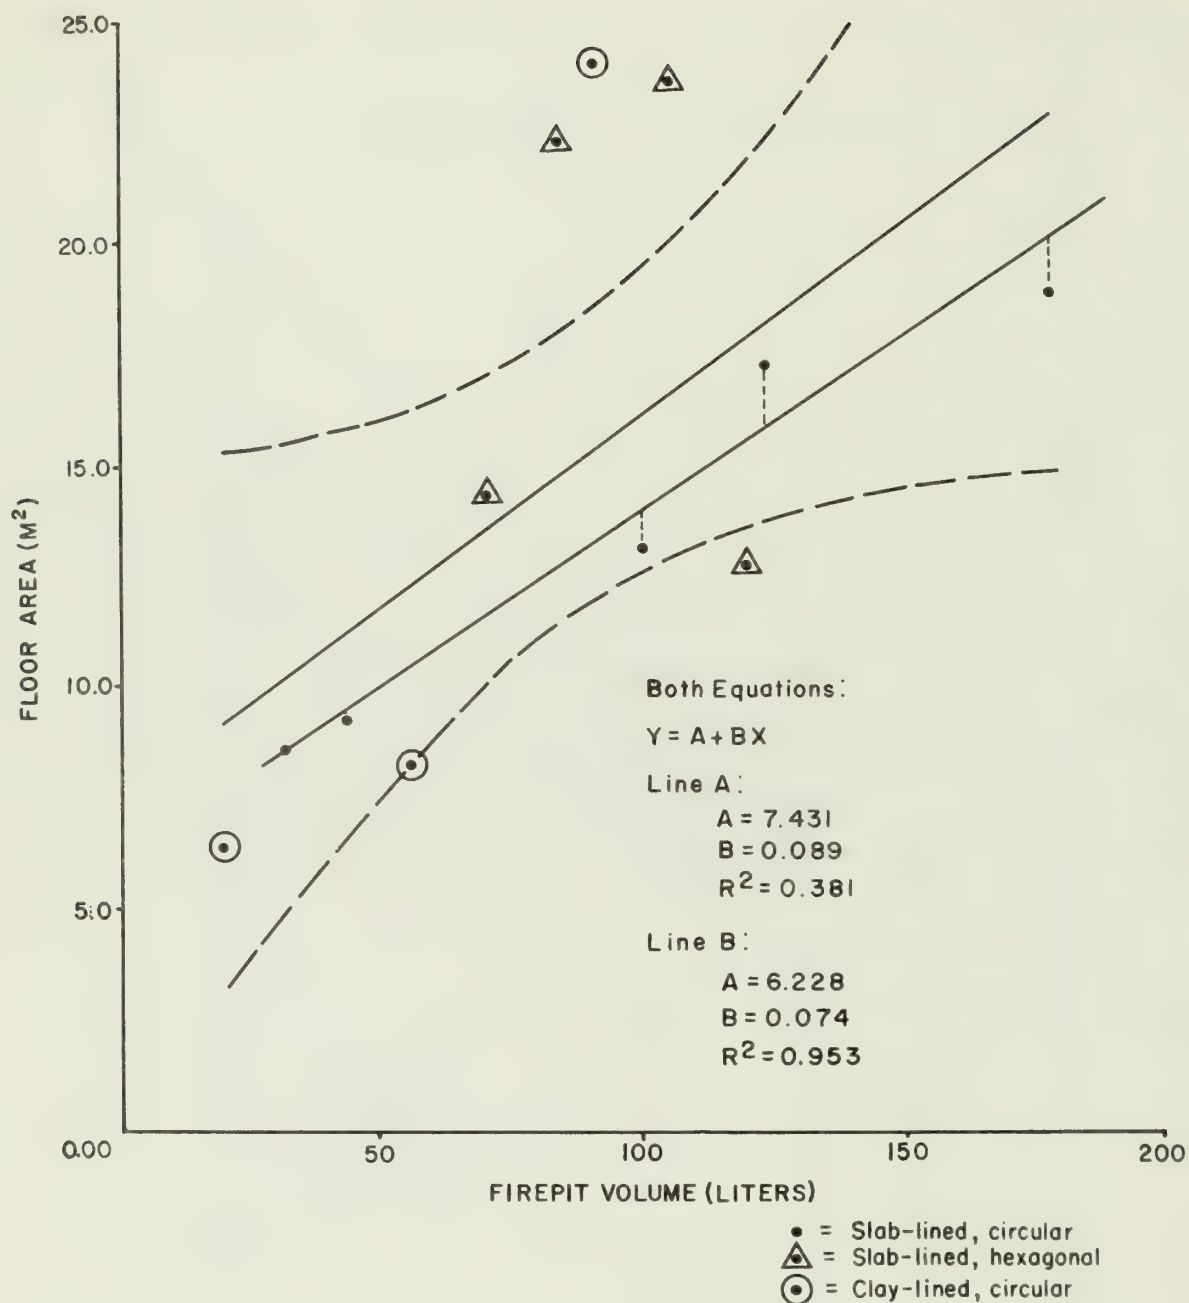
Figure 1.4. Pithouse floor area (Y) and firepit volumes (X), A.D. 700-900.

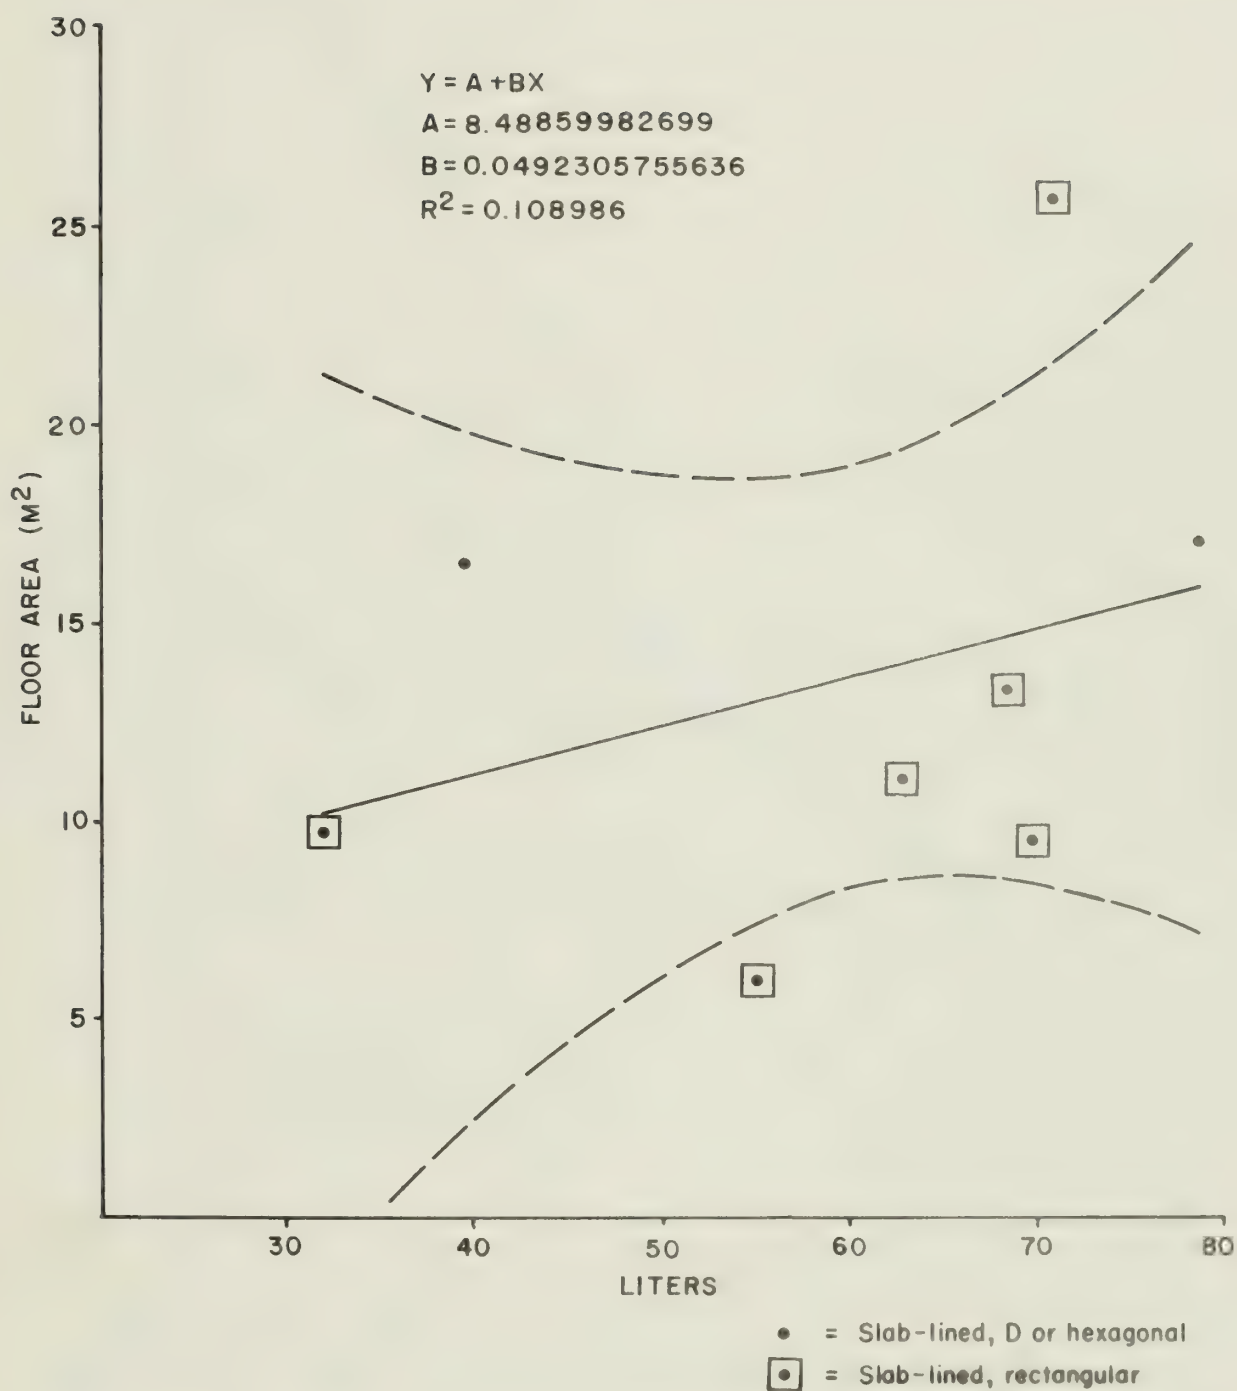
Figure 1.5. Kiva floor areas (Y) and firepit volumes (X), A.D. 900-1100+.

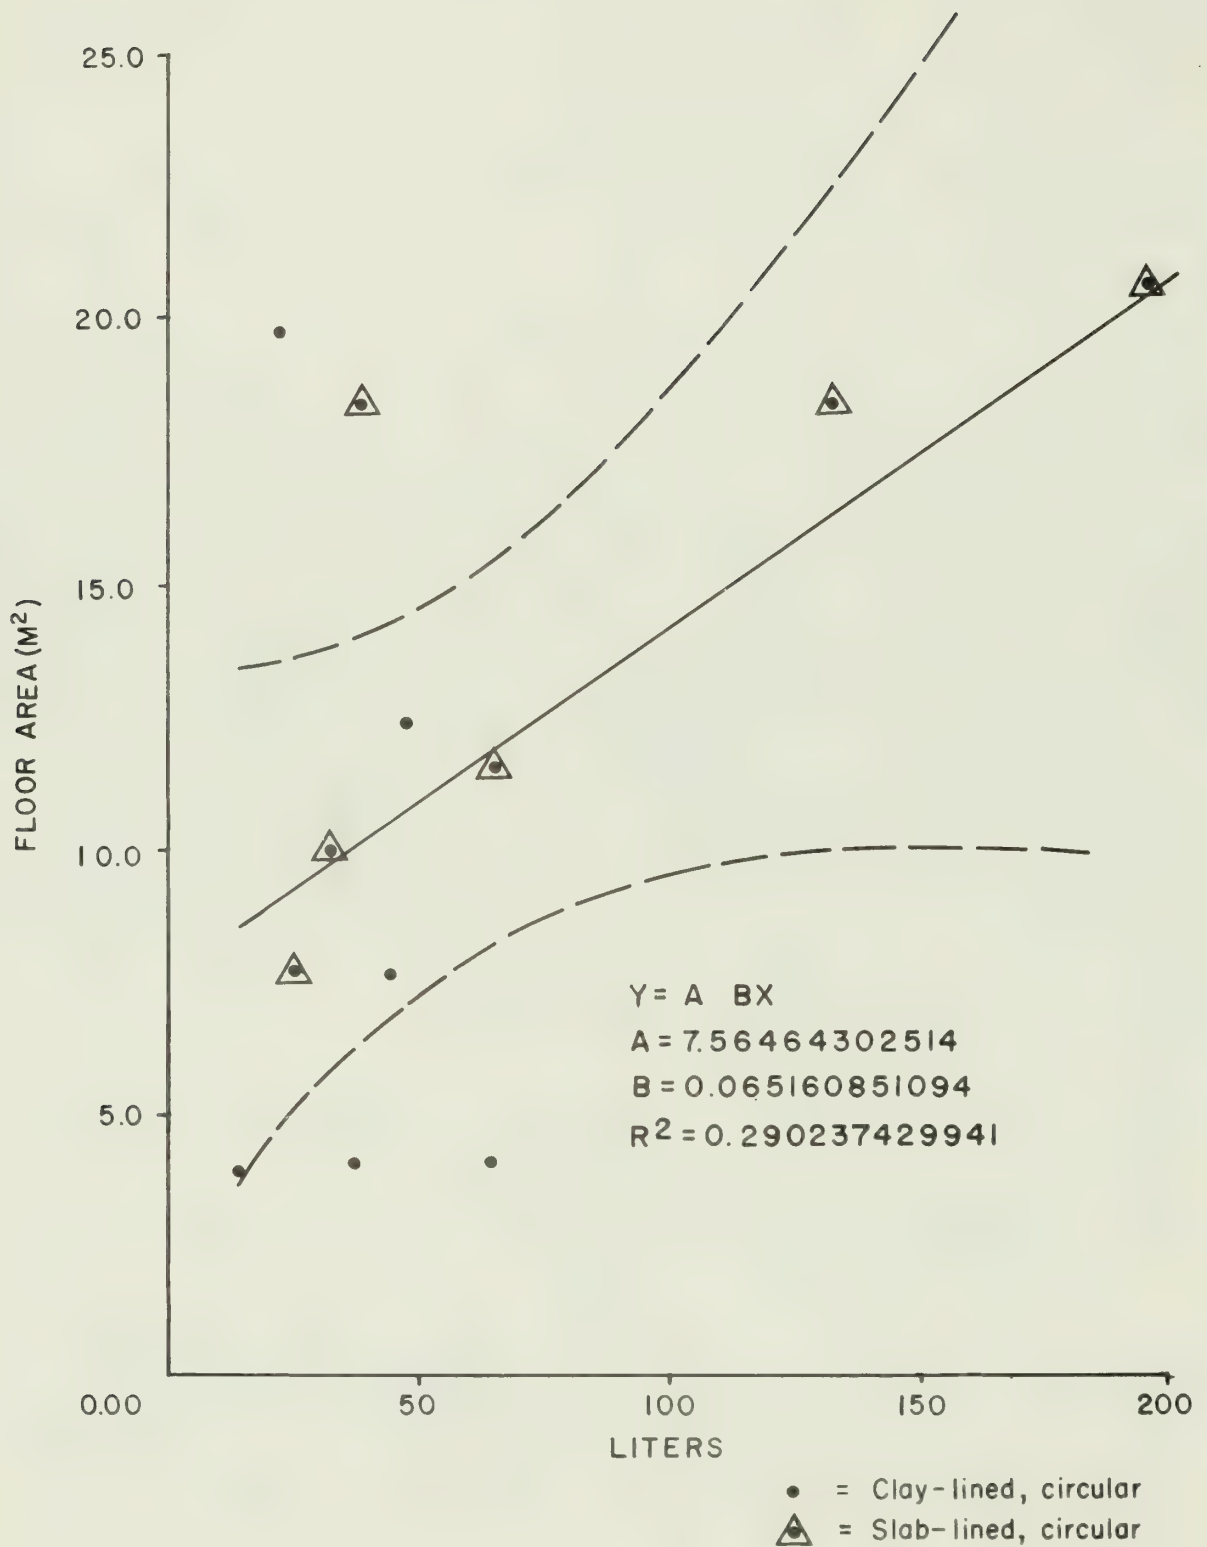
Figure 1.6. Room floor areas (Y) and firepit volumes (X), A.D. 700-900.

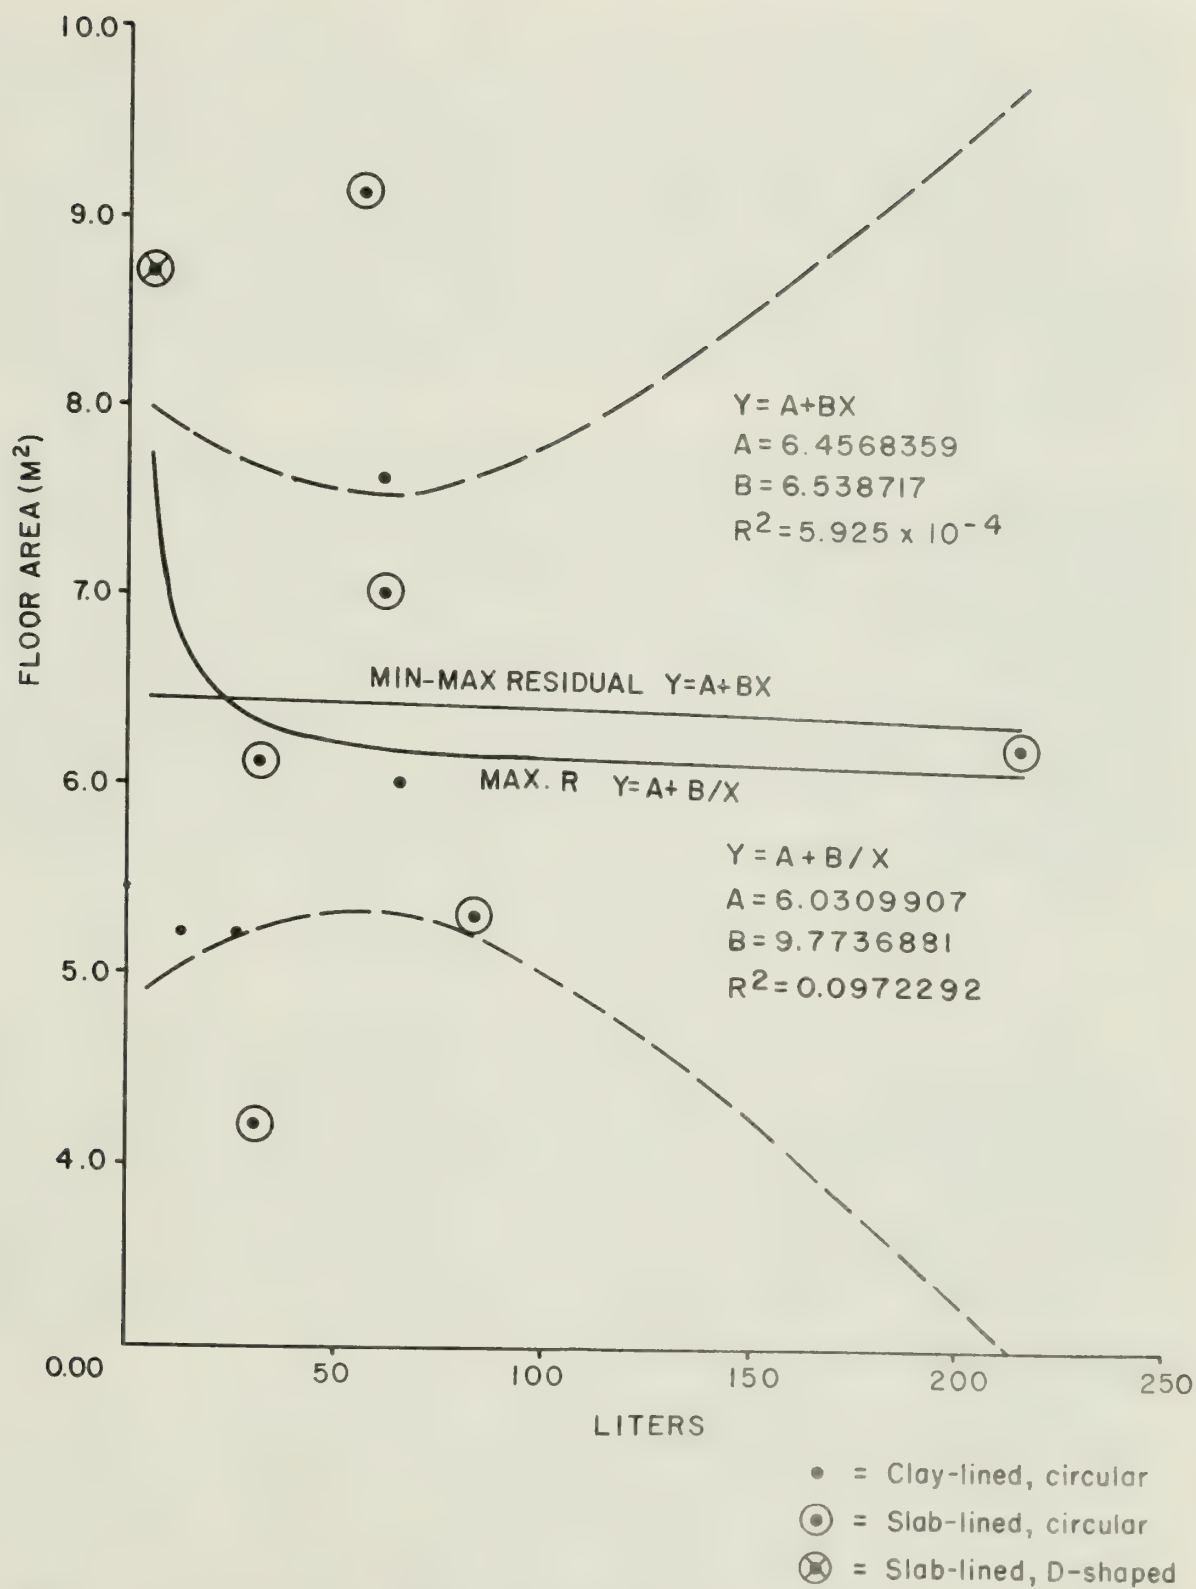
Figure 1.7. Room floor areas (Y) and firepit volumes (X), A.D. 900-1100.

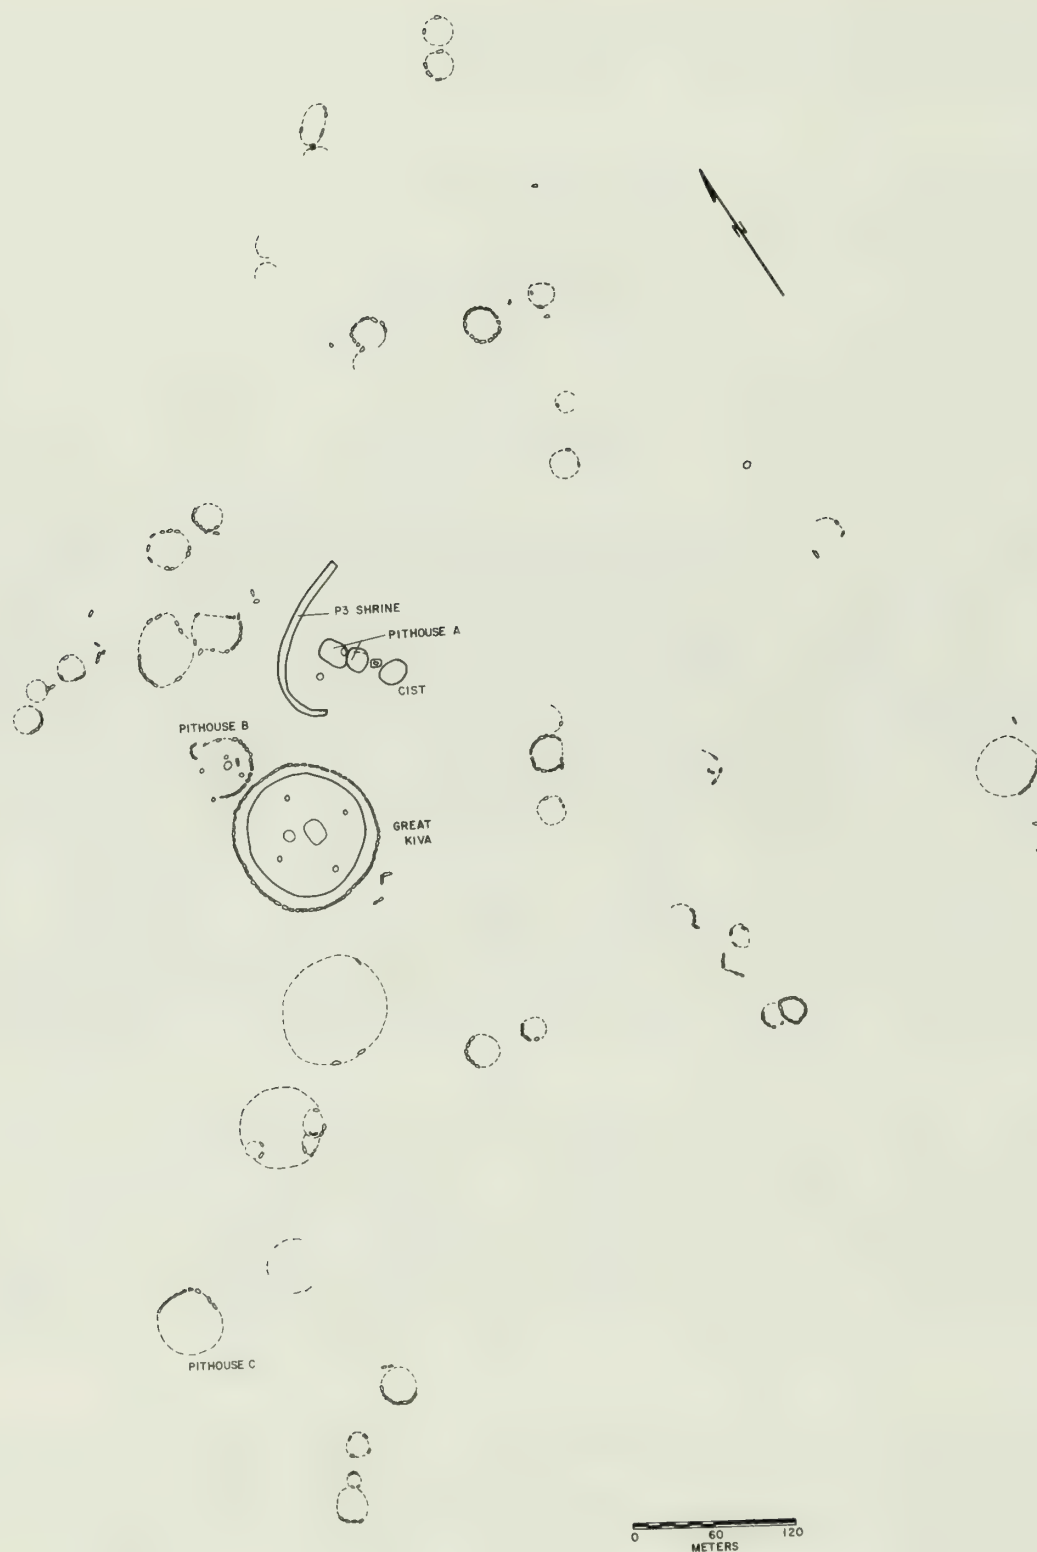
Figure 1.8. Site 29SJ 423 (after Windes 1975a).

In the center of the site, south and west of the shrine, was the Great Kiva. Evidence of three superimposed Great Kivas, one over the other, was noted; all had been destroyed by fire. Approximately 40 years may account for the construction of the three Great Kivas: Great Kiva 1 between A.D. 520 and 540, number 2 between A.D. 540 and 550, and number 3 after A.D. 557. The earliest and largest Great Kiva was similar to those found in the Mogollon area in exhibiting peripheral roof post supports. Brownwares were associated with this structure. Trash deposits and construction of walls and a new roof support system suggest a hiatus between the first Great Kiva and the construction of the second. Although some new ground was broken for the second Great Kiva, extensive remodeling of the bench continued to reduce the floor space. With the second Great Kiva a centralized four-post roof support plan was adopted and maintained during the structure's remaining use. The middle structure exhibited a haphazard arrangement of secondary support posts on the main floor, while the final episode of use saw these lateral posts shifted to the bench. Using evidence of structural deposits and engineering data pertaining to timber stresses from reconstructed roof loads, Windes has argued the third Great Kiva was, at least partially, not roofed.

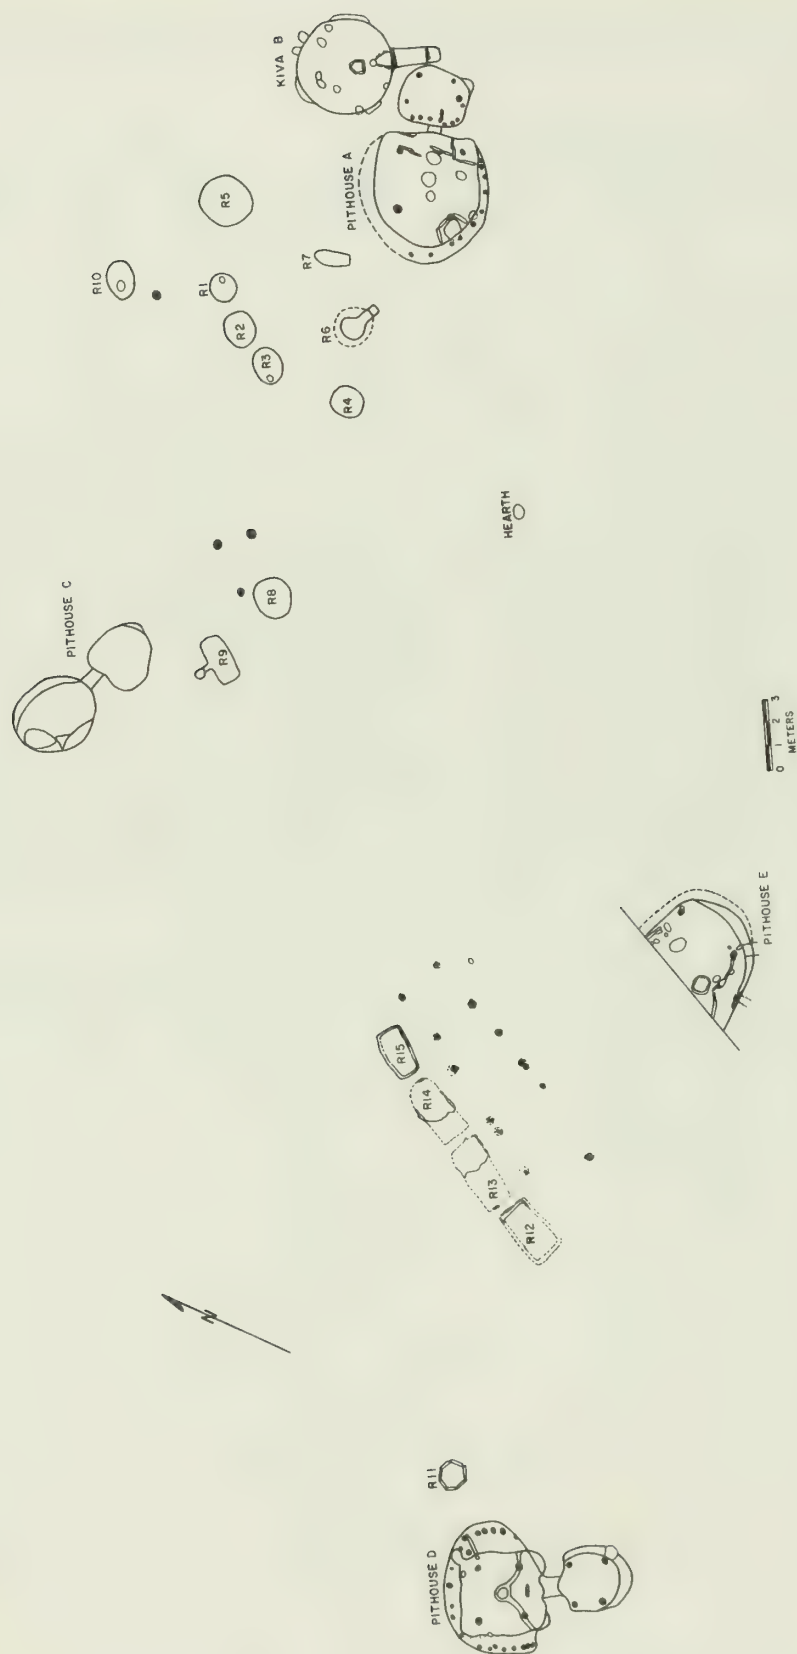
Figure 1.9. Site 29SJ 299, A.D. 500s-early 700s portion.

Loose uncovered three pithouses and attendant storage cists, an intrusive Pueblo II kiva, and a Mesa Verde period trash deposit on the north side of Pithouse A (probably another intrusive kiva). One of the Basketmaker pithouses, C, was an uncompleted structure without roof support molds, hearth, or finished bench and floor area that, later, had been used as a trash pit. The antechamber has been reused as an adobe mixing pit and wash from this area capped the trash deposits in the main chamber. Excavation of this structure provided evidence of some of the planning and procedures implemented in constructing a pithouse.

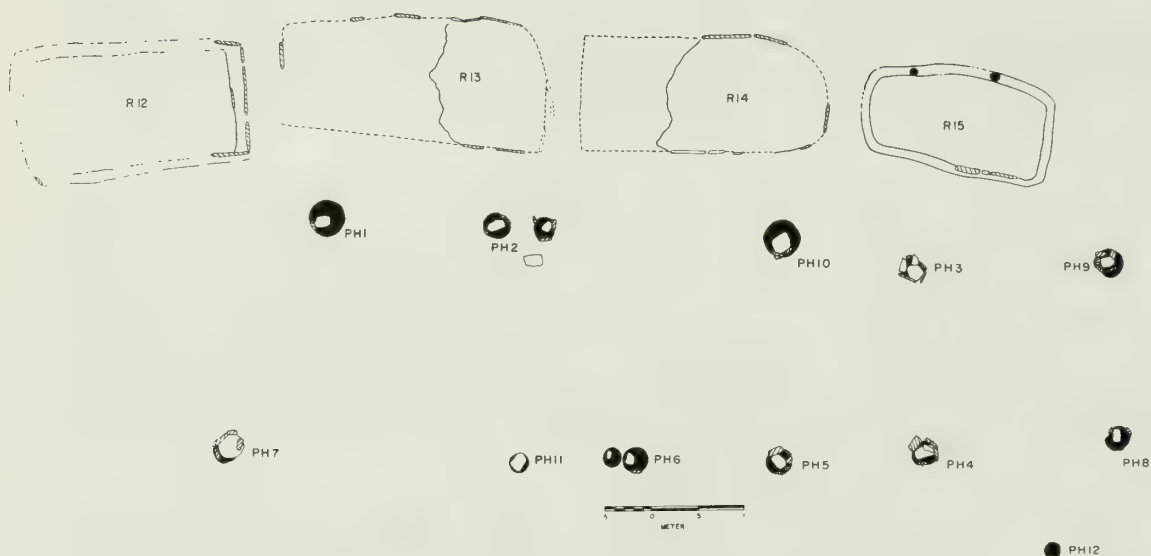
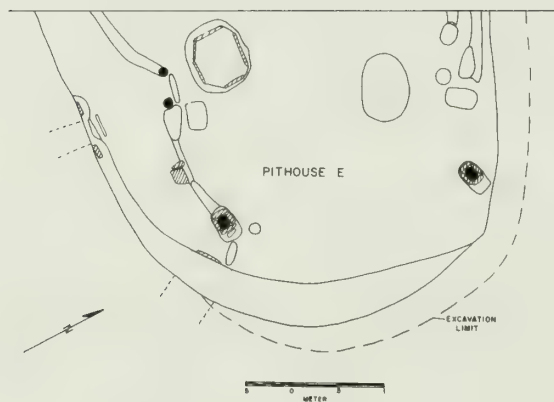
Figure 1.10. Site 29SJ 299, P-I component (after Windes 1976a).

Although Loose does not discuss site demography, Windes believes that architectural evidence and the paucity of trash suggest construction and short-term occupation by a single nuclear family in Pithouse E of the Pueblo I component (detailed in Figure 1.10). In support of this conclusion, Windes notes the architectural similarity of rooms 13 and 14 and the positioning of the pithouse directly in front of them, suggesting that these were the first structures built. Intrasite population growth might be indicated by the slow architectural development of the roomblock. Rooms 12 and 15, constructed without slab foundations, were probably built later. The position of the postholes of the fronting ramada suggest an initial trapezoidal construction in front of rooms 13 and 14 with a later, smaller, rectangular group centering on Room 15. The lack of a fronting

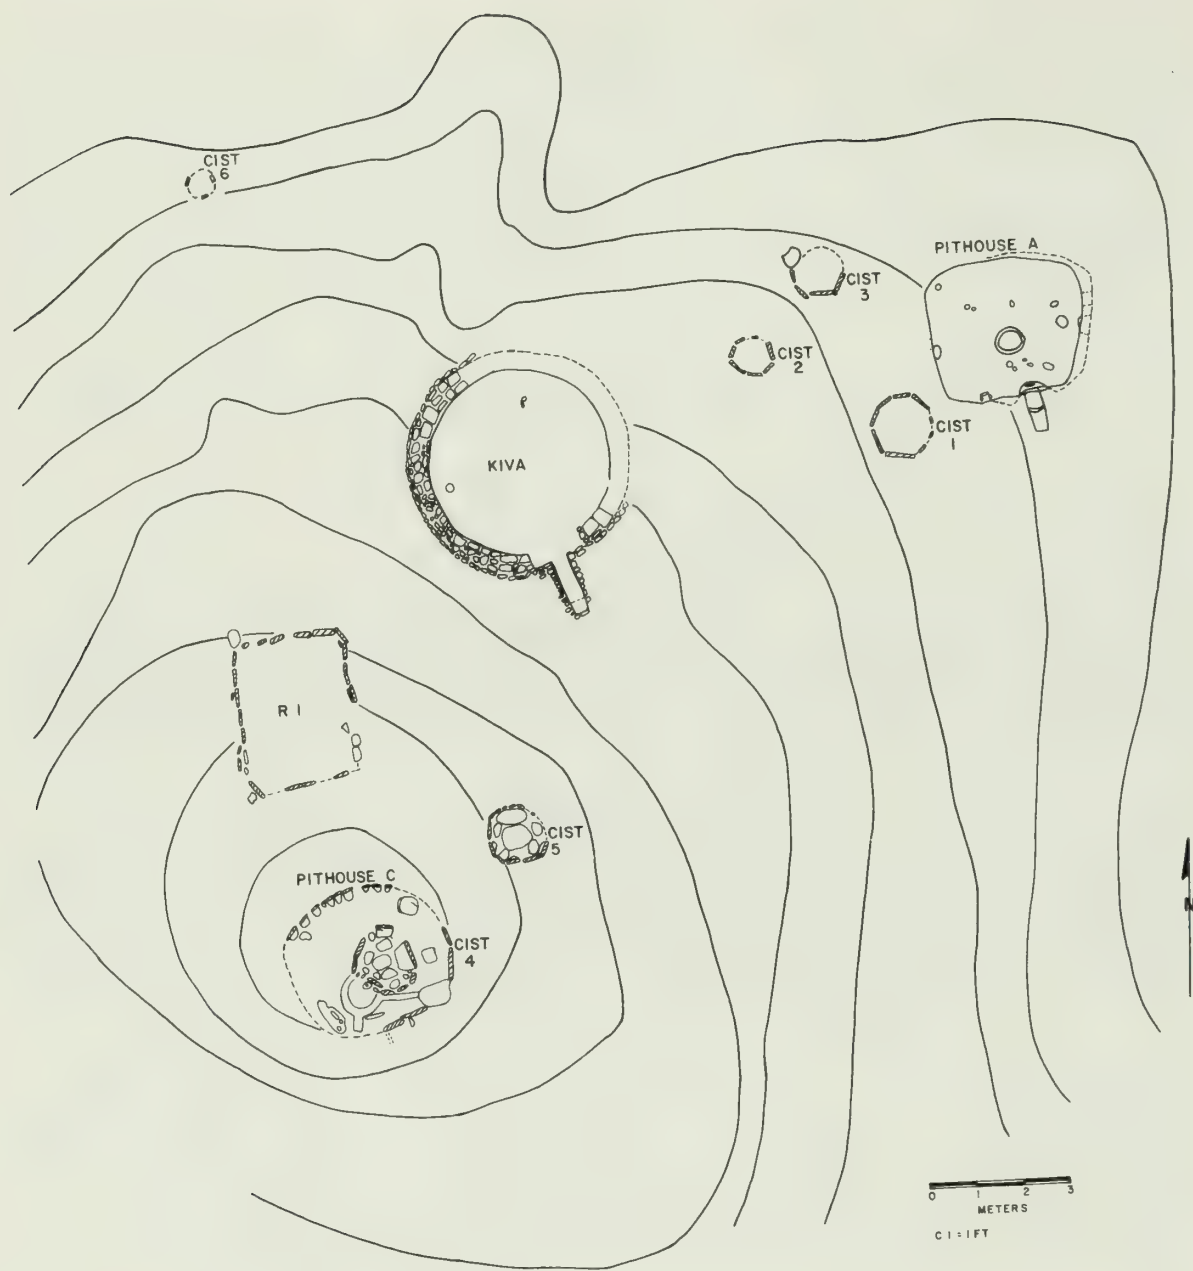
Figure 1.14. Site 29SJ 721 (A.D. 600-late 700s?) (after Windes 1975b).

Located a little east from the mouth of Werito's Rincon, 29SJ 721 was excavated and reported on by Windes (1975b). Two pithouses, six cists, a Pueblo I room, and a Pueblo III kiva were excavated (Figure 1.14). Dimensions of site features and associated dated material may be found on Table 1.15.

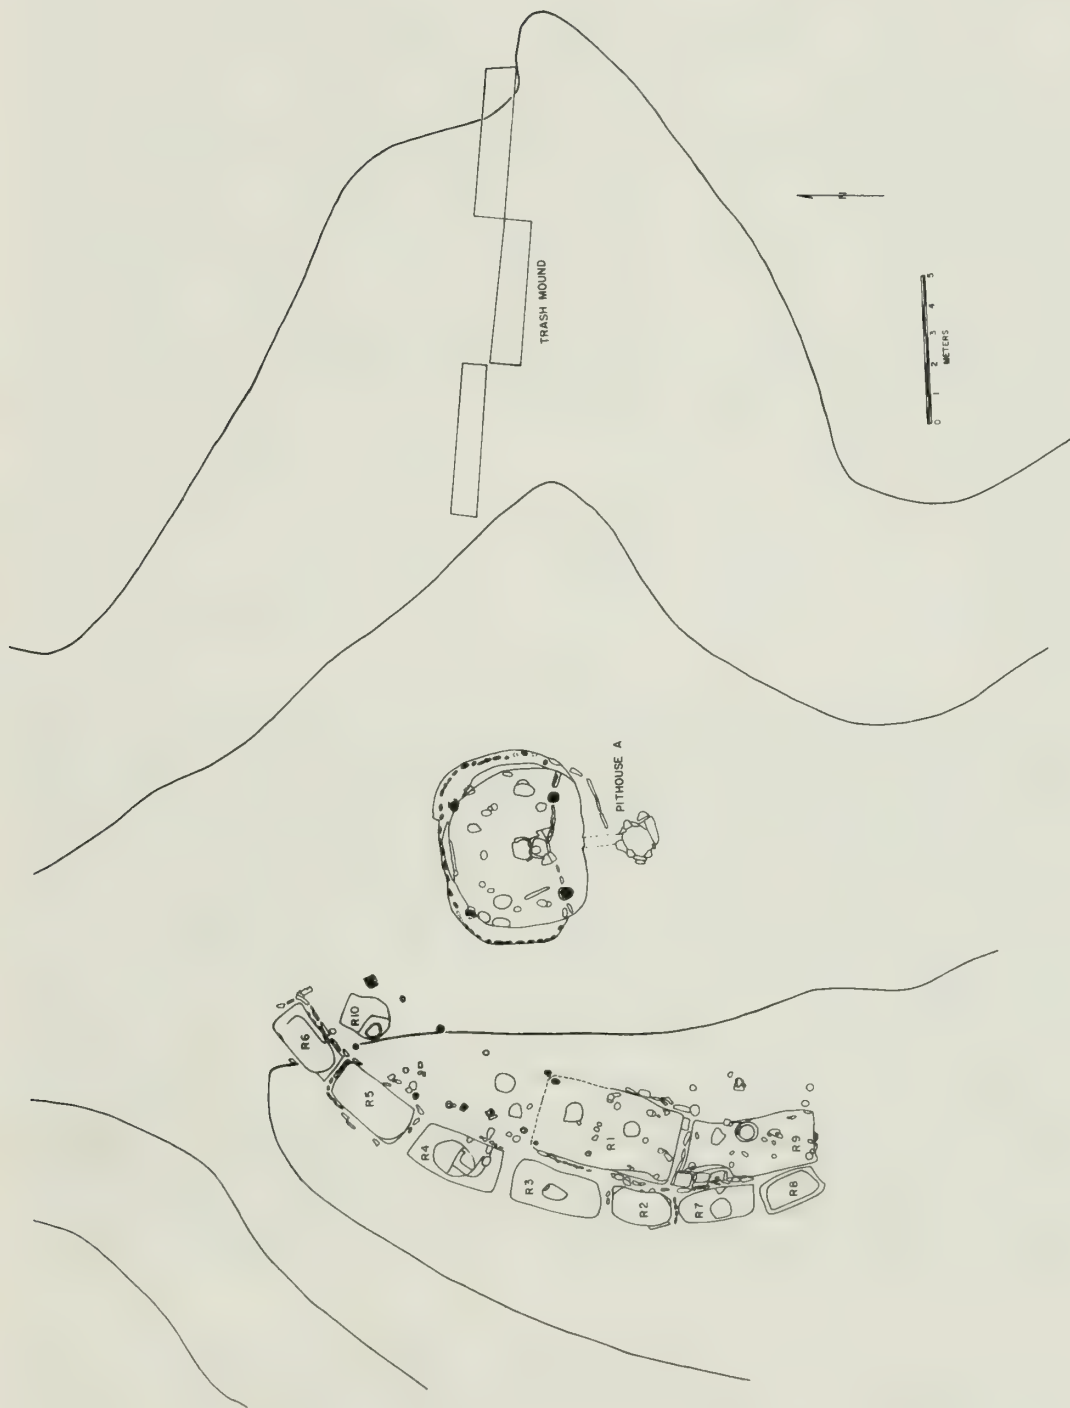
Figure 1.15. Plan view of 29SJ 724, Roomblock 1, after excavation.

The rooms formed a curvilinear arc to the west of Pithouse A. All rooms were semisubterranean and architecturally distinguishable as either living (2) or storage rooms (8). Living rooms were characterized by light

walls, shallow rectangular floor plans, firepits, and tools scattered about the floor. Storage rooms, backing the ramada and living rooms, were generally ovoid, tub-shaped in cross section, and considerably deeper, but generally lacked floor pits; no firepits or floor-associated artifacts were noted. The rooms evidenced structural collapse, primarily that of adobe in the storage rooms. The wall fall in the living rooms (1 and 9) suggests a standing wall height no greater than 1.5 meters. Storage rooms were probably no higher than a meter and seem to have been roofed by light poles and brush while post supports and other evidence in the living rooms suggest a roof similar to, and possibly continuous with, that of the ramada. Two types of storage rooms were present: small, deep, tub-shaped rooms and larger, shallower basin-like ovoids. The smaller, deeper rooms are associated with the living rooms while the larger storage rooms back the ramada. This difference in structure prompted Windes to suggest a seasonal use of these rooms and/or the meeting of differential storage and preservation requirements of different foods.

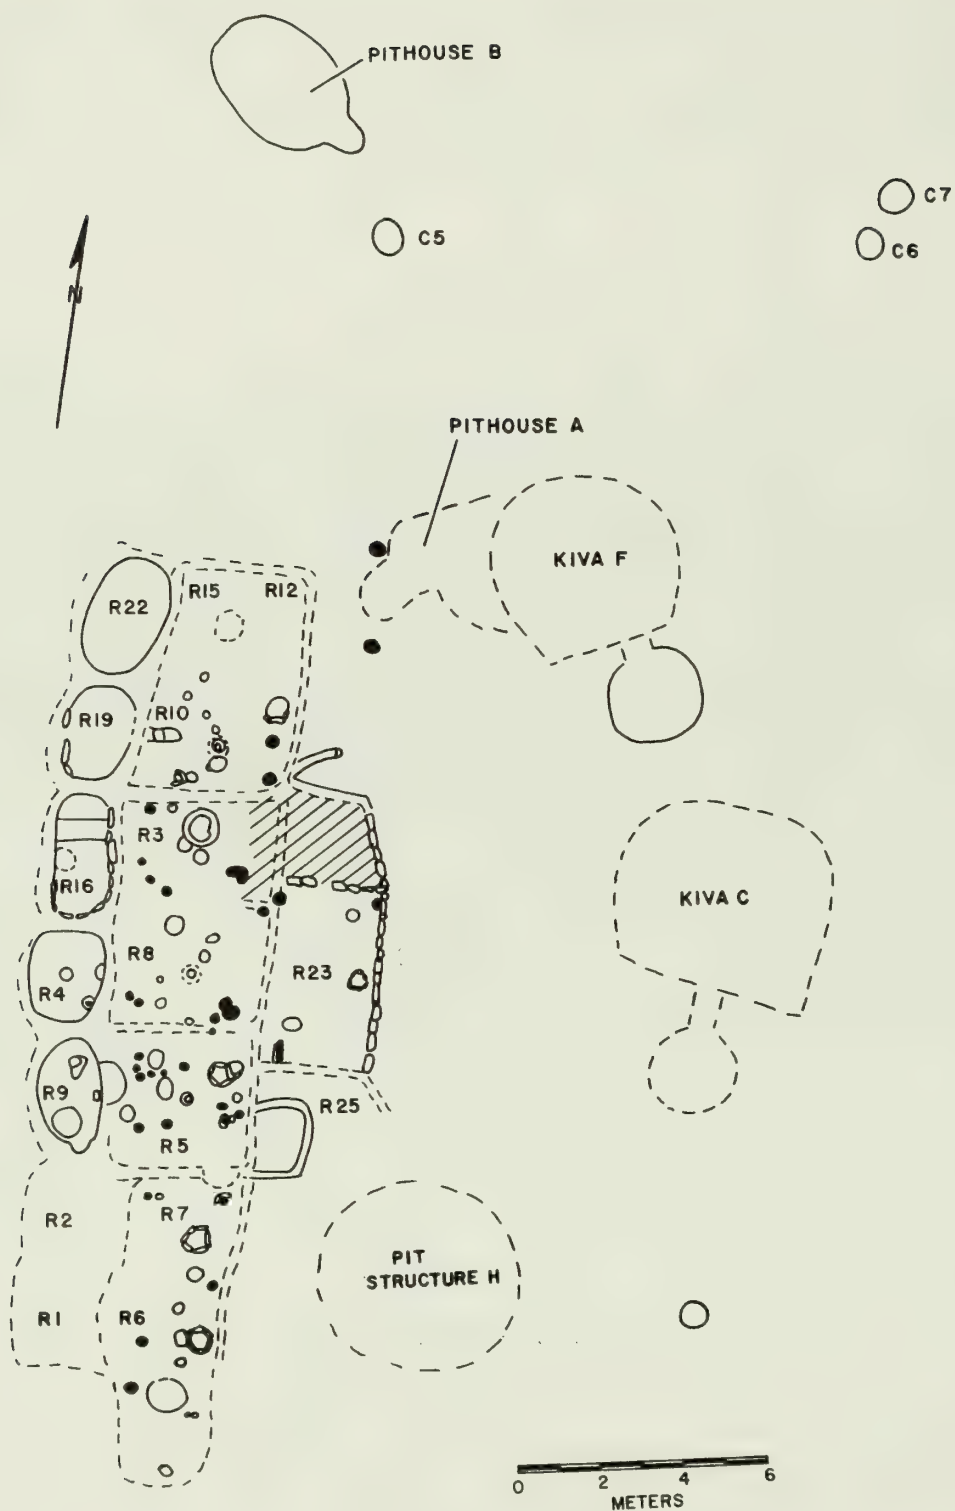
Figure 1.18. Site 29SJ 627, first construction A.D. 780-910+.

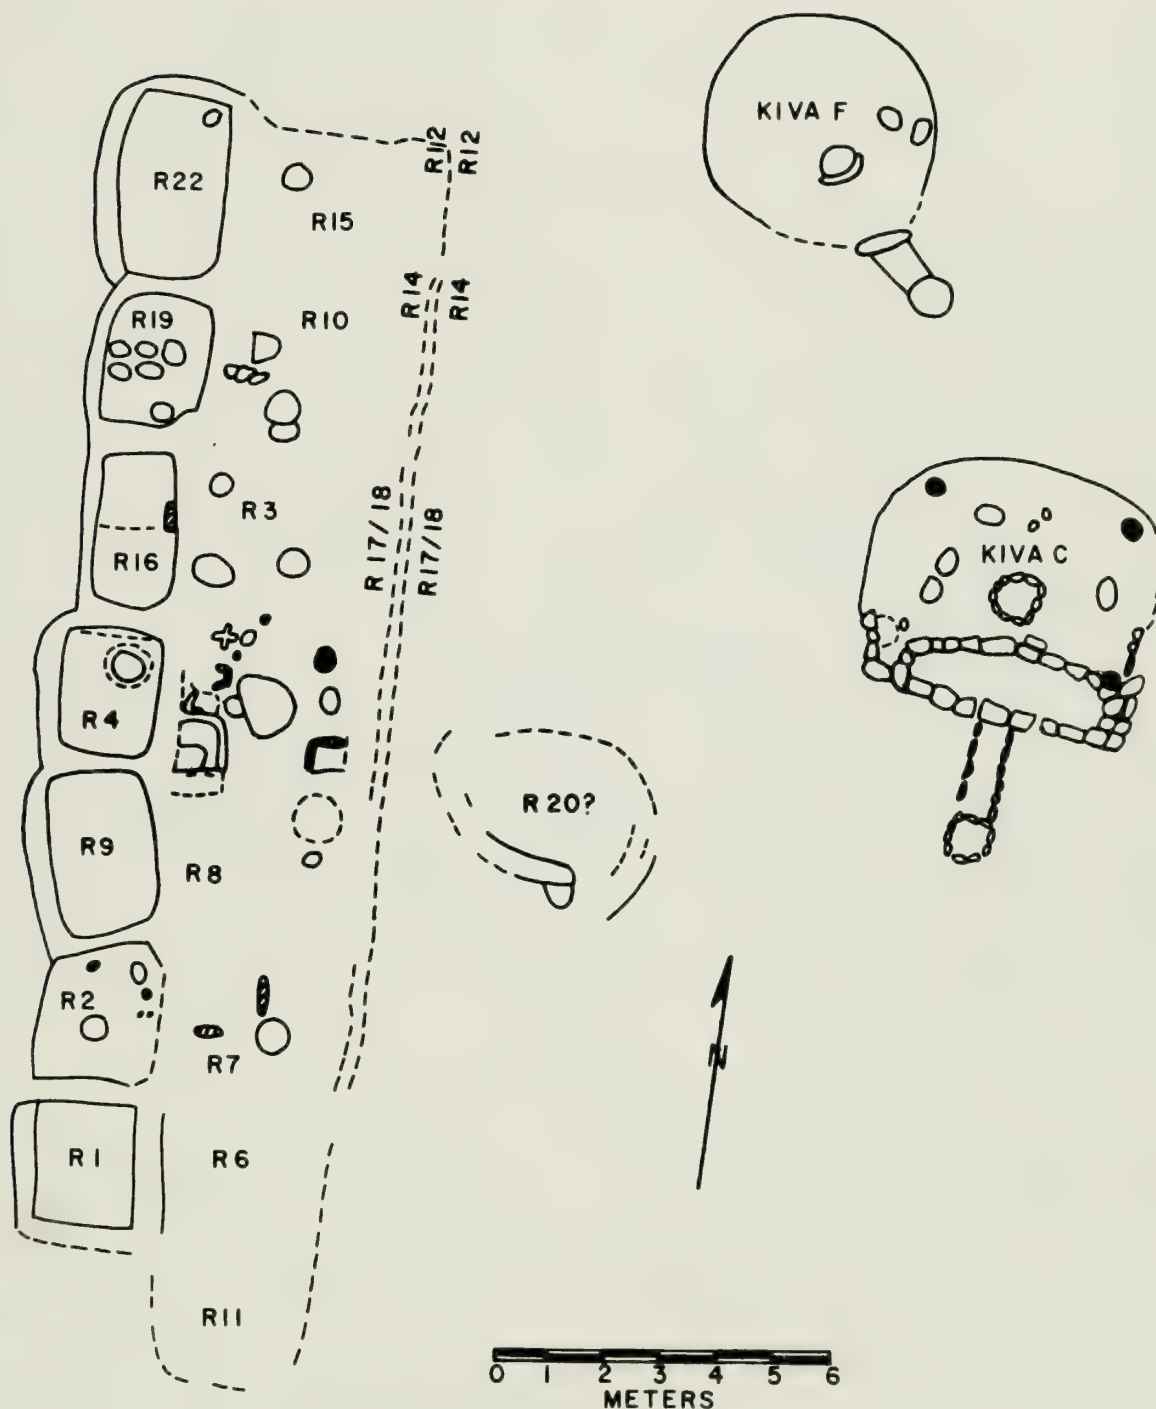
Figure 1.19. Site 29SJ 627, second construction A.D. 950-1000.

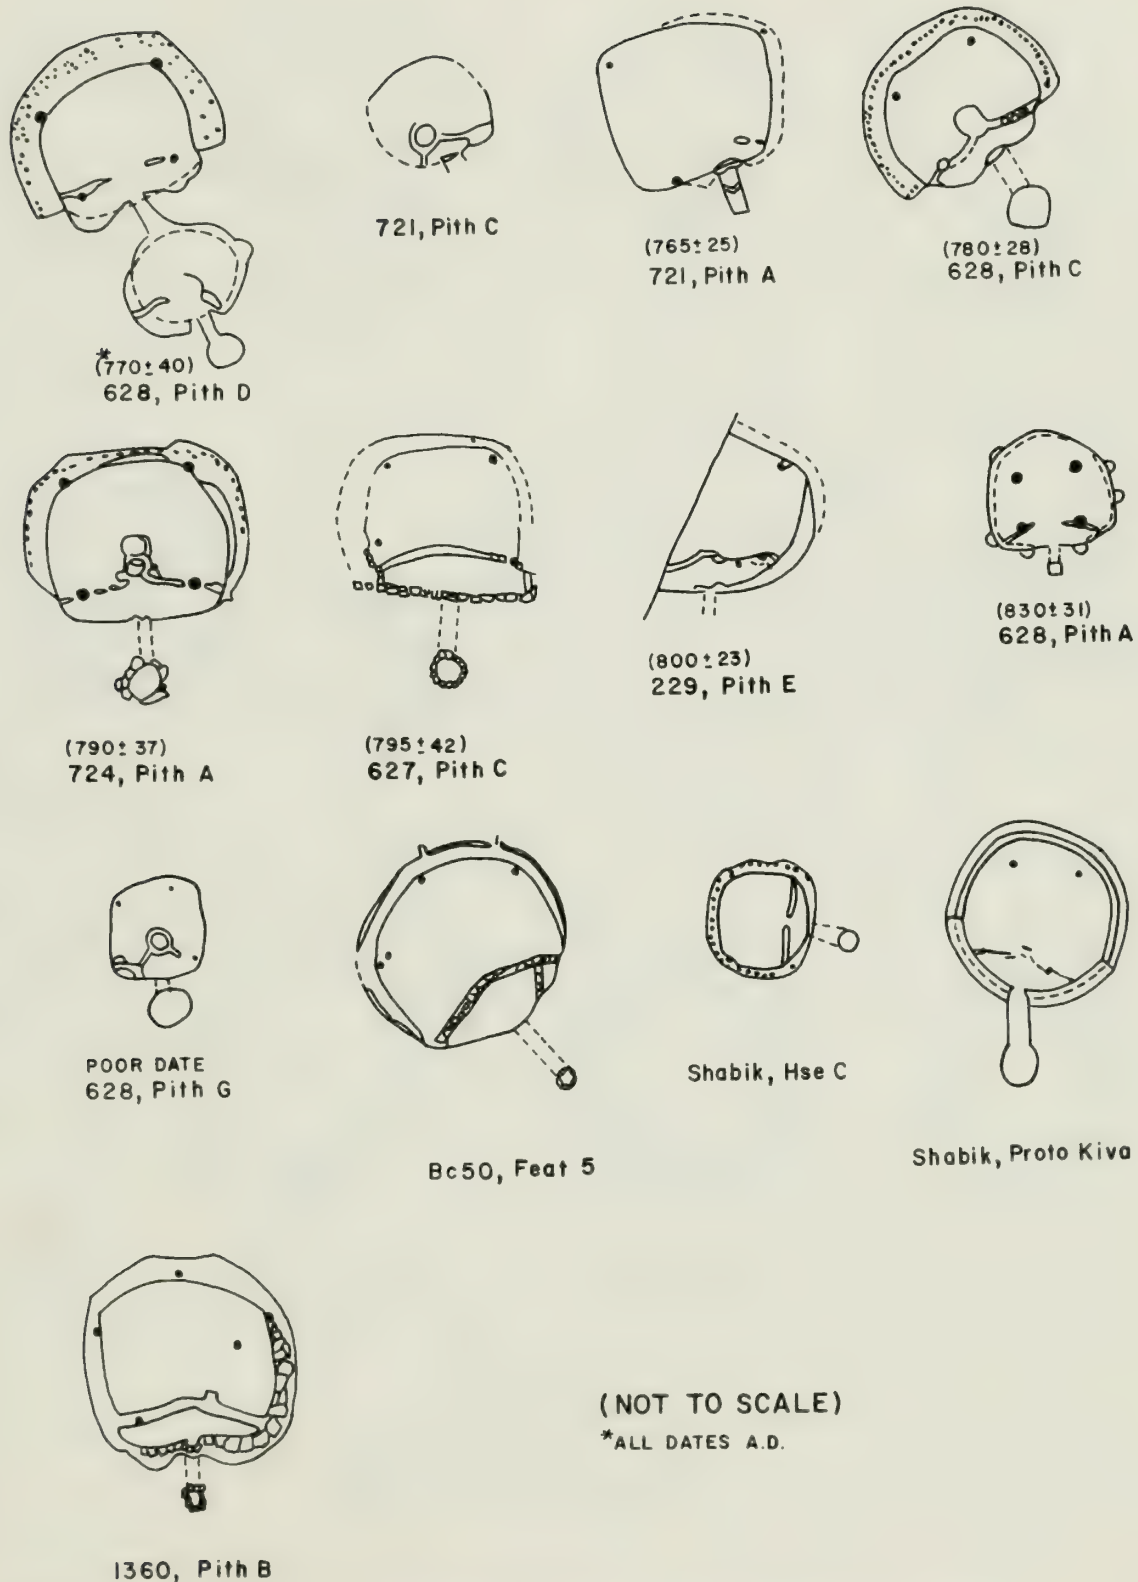
Figure 2.6. Middle 700s-early/middle 900s pit structure shape.

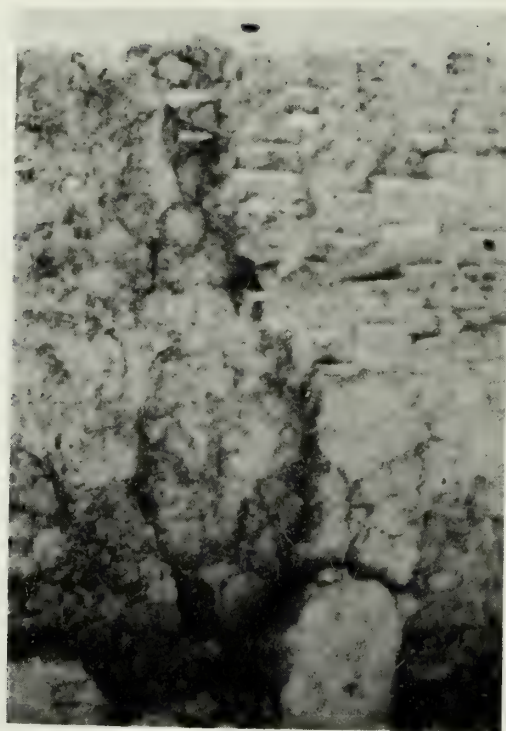
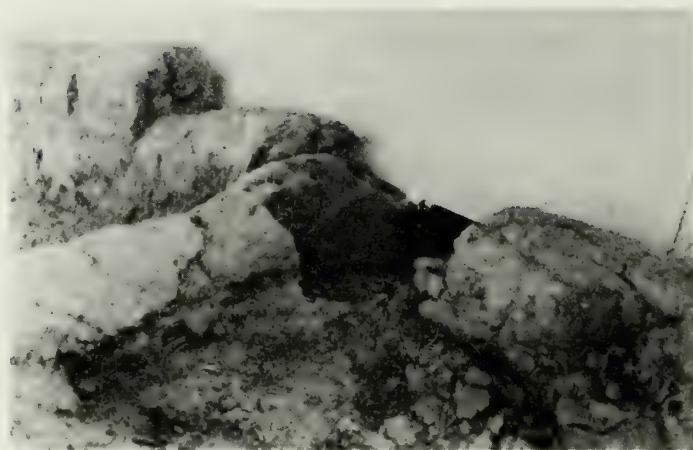
Figure 2.12. Cross section of a 700s-900s wall. (a) Wall section;
(b) Detail of turtleback.
